**Summary of Fish Inventories at Selected Road-Stream Crossings Assessed for  
Fish Passage Status, Monongahela National Forest, 2014**

**Report prepared by:  
Colin Krause  
March 2015**

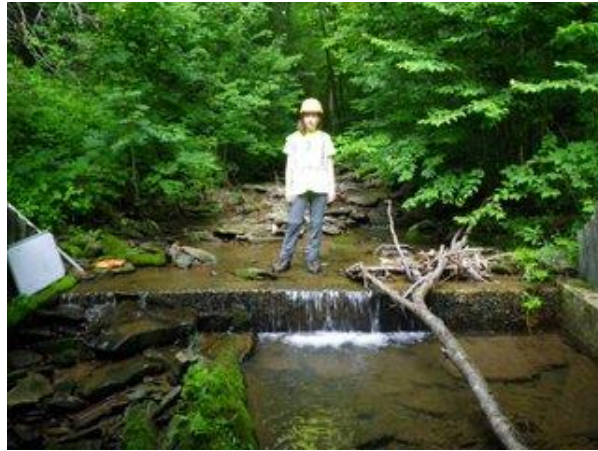
One of the sites, WV12 (Little Low Place) which had continuous substrate (the structure is an open bottom arch) has a small cement dam at the inlet, which when included in the survey changes the passage status of Filter B and C from passable to impassable (Table 3 and Appendix B). Overall, the majority of the 10 crossings were impassable or indeterminate for fish passage.

\*Survey results shown for Little Low Place exclude a small cement dam at the inlet of the open bottom arch, which when included in the survey changes the passage status of Filter B and C to from passable to impassable.

WV12 Dam at inlet of open bottom arch

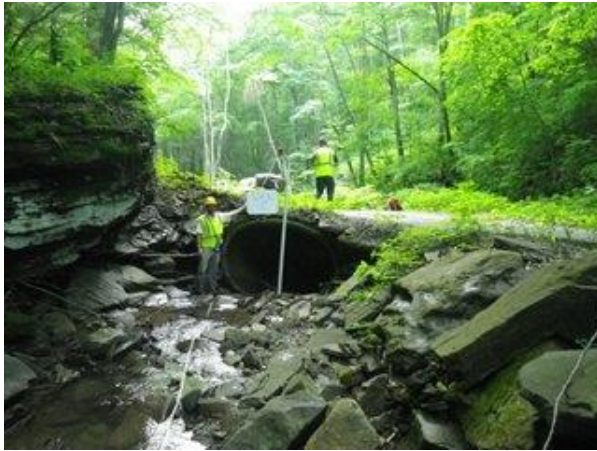
WV21 Inlet, Whites Run

WV21	Whites Run	1 of 1	No	1.8	3	31	81	Indeterminate	Impassable	Impassable
	WV22	Smith Run	1 of 1	No	2.5	6	47	286	Impassable	Impassable	Impassable
